Paper Number: 19

Evaluation of Period of Vibration and Vulnerability Assessment of a Historical Masonry, Sama Center: A Case Study

Pooja Amatya^{1,2}, Rohit Ranjitkar^{2,3}

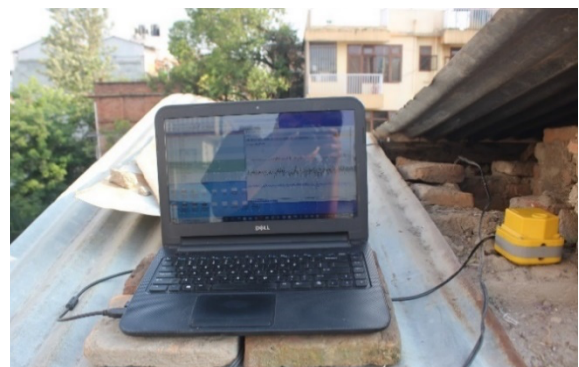
camera was used. For the building, one vertical and two horizontal measurements (east and north) were recorded, with a sampling rate of 100 Hz and a duration of 5 minutes for each location. The instrument was placed on each story wall. The topmost level of the existing building was reached as shown in ‘Fig 3’.

Figure 3. Data Collection at site. The highest point accessible in the mid longitudinal wall

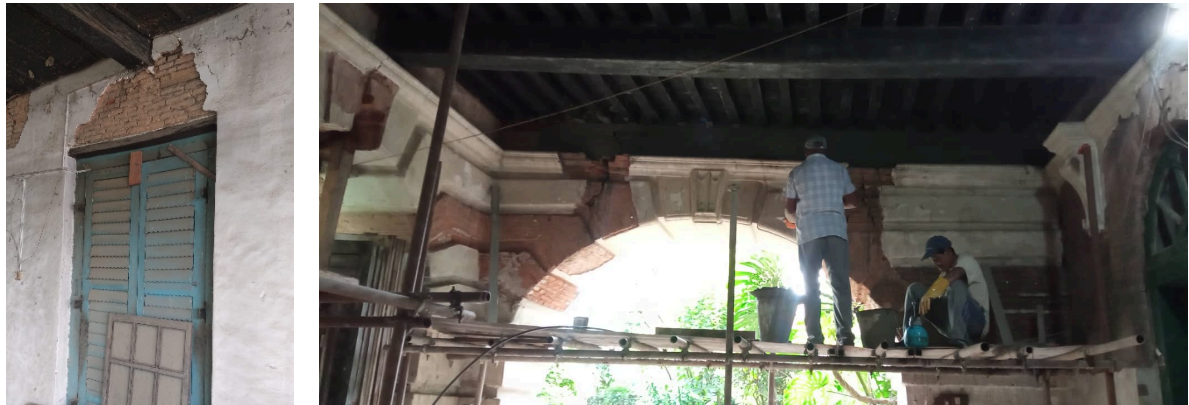
The axial stress patterns in the two elevations are as shown in ‘Figs 8 and 9’. The average compressive stress is 0.5N/mm² which is within the limit whereas the tensile stress is exceeded in some openings as recorded after the

earthquake in the building as shown in ‘Fig 14’. The foundation of the building was checked for its bearing capacity for four story which resulted safe.

Figure 14. Photographs of the cracks in the openings and the arches after the 2015 earthquake

The stresses of the building have been observed through the finite element method. The building acts well in compression and shear since the walls are thick. Certain local stresses have been seen in the horizontal bending when analyzed using the Dynamic Analysis Method on the third floor which is due to the presence of a balcony that rests on tall columns and fewer cross walls. A diaphragm should be created to increase the stiffness of the balcony and the third floor whereas the local stresses in the corners of the openings can be strengthened using some wire mesh inside the plastered surface.
